**Cost-effective
Pump Repairs,
with Innovative
Solutions!**

Case Study Vertical, Diffuser Bowl, Lineshaft (VS1)

Sea Water Lift Pump
Sea Water

Peerless (Grundfos)
18 HXB x 2 Stage

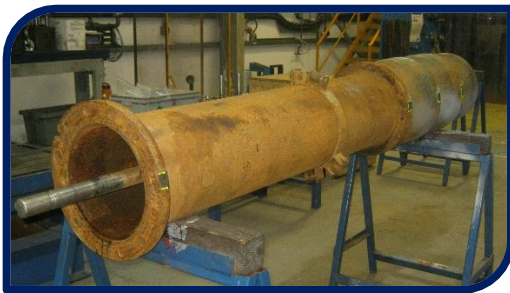
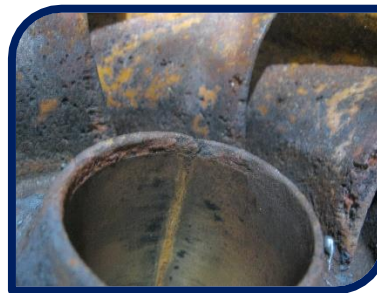
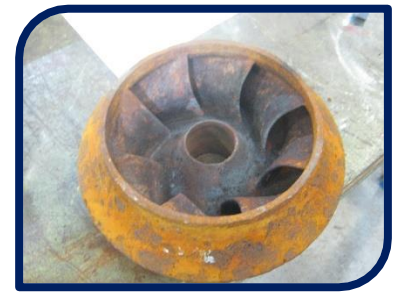
Sea Water Lift pump string from a UK offshore late-life asset. The pump materials used are reflective of the age of the platform, and although some materials had been upgraded, such as the Impeller Shaft to Super Duplex, the impellers and other wear parts were suffering badly from corrosion. The column spigot fits were also found to be out with acceptable tolerance.

Pinnacle Re-Tec reverse engineered and manufactured in-house the required replacement parts such as, impellers from Ni-Resist Cast Iron and shafts in Super Duplex, with pattern and casting produced in the UK. To repair the out of tolerance spigot locations, Pinnacle Re-Tec machined repair rings, fitted & pinned them, and finished machined to required size in-house. We also fitted and finish machined the bearing bushes out of the original Fluorosint™ material.

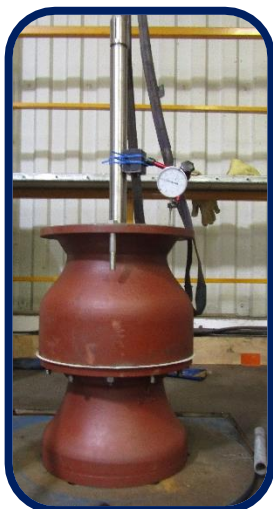
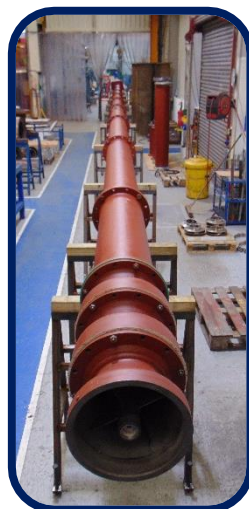
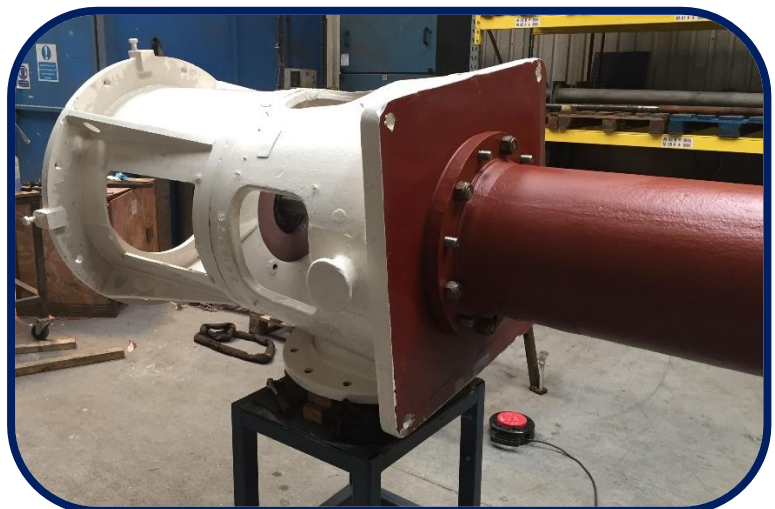
This **'one-stop-shop'** offering by Pinnacle Re-Tec, provided the customer with an on-time and cost effective pump repair which included a full trial assembly of the 25m long pump string, inclusive of the Discharge Bend, Thrust Bearing Assembly, Motor Stool and Coupling Hub.
