## Case Study Multi-Stage Split Cartridge, Barrel (BB5)

Duty & Fluid	OEM & Designation	Materials
Boiler Feed Pump. Water	Flowserve 6 stg type 8WNC136 Boiler Feed Pump	Carbon Steel Hydraulic components, Stainless Steel shaft.

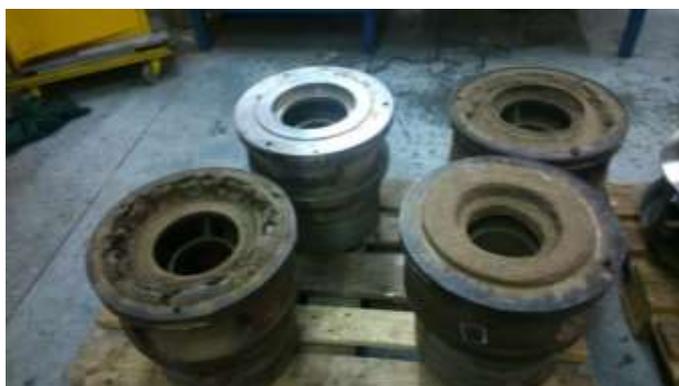
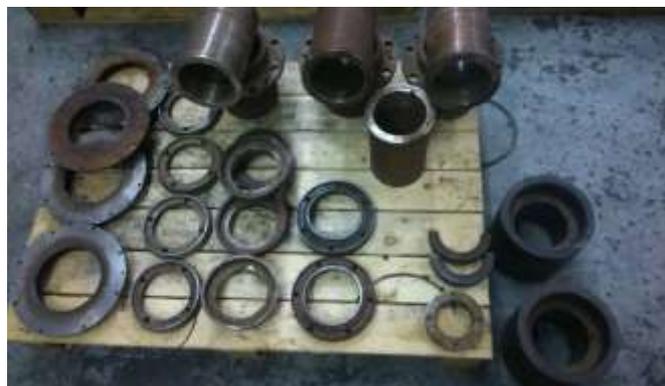
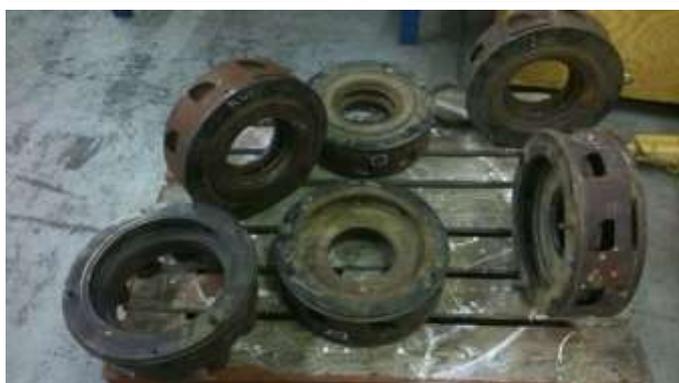
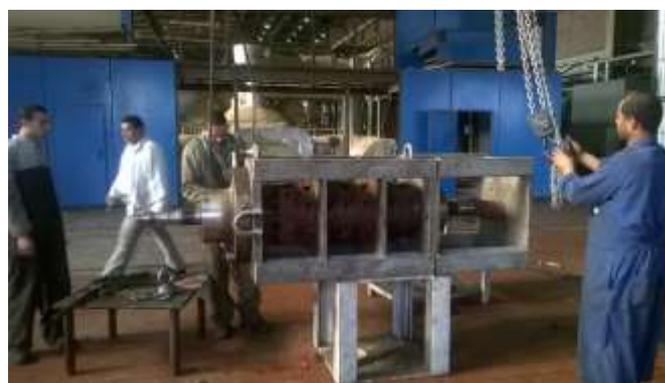
Customer required overhaul of 2 off 6-stage ring section cartridges for their Boiler Feed Pumps at Cairo West Power Station. We inspected the disassembled parts on site and found that both pumps had suffered from a collision of the rotor, one more than the other. Some of the casing parts had major damage and most of the rotating parts were beyond repair. The customer was also able to provide 2 transport jigs for the cartridges to minimise the risk of damage during transport and an assembly jig for the vertical assembly. Our team was then able to assist with the assembly of the old pump parts and transfer the cartridges into the transport jigs.

Based on this assessment, we were able to determine the requirement of new parts and refurbishment. While most casing parts were repairable, many new parts were also required. Shafts, impellers, bearings and wear rings as well as spring reinforced stage seals had to be replaced.

Pinnacle Re-Tec reverse organised the transport back to our facility in the UK where we reverse engineered and manufactured the required spare parts in-house. The damaged parts were weld repaired by 3<sup>rd</sup> party with full weld procedures in place, then machined to finish size in -house at Pinnacle Re-Tec. It was agreed with the customer to change the bearing locations on the shaft from chrome oxide coating to full chrome for a longer lasting result in combination with the thin shell bearings. All consumables were also drawn up and sourced from specialist suppliers.

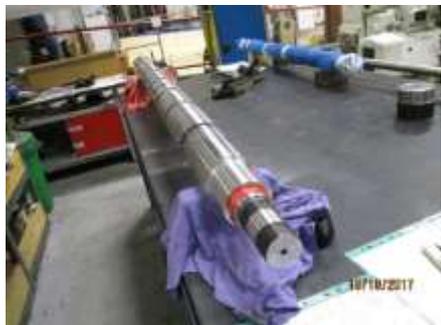
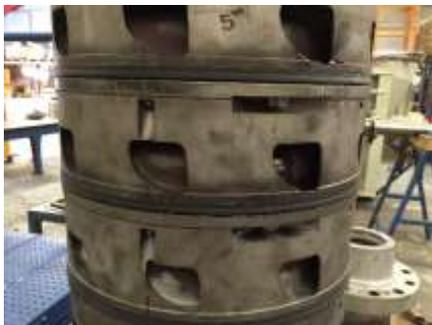
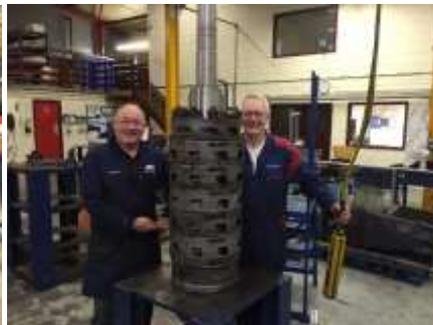
New shaft, stack with seals and complete cartridge assembly with new rotor

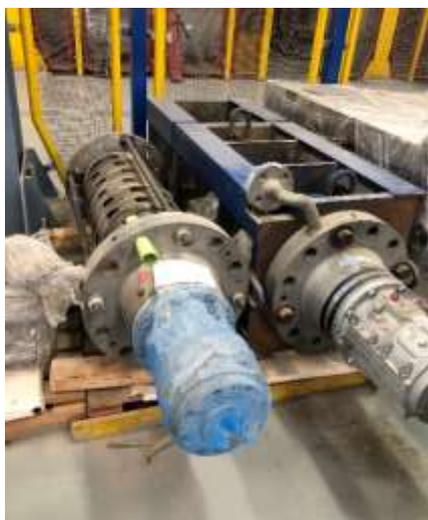
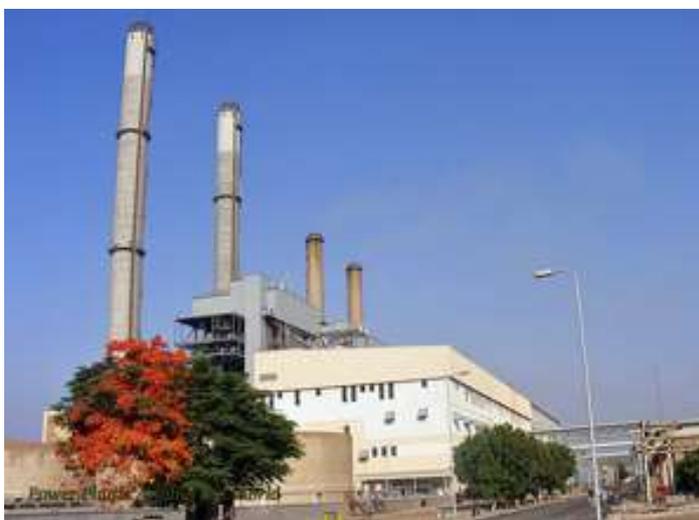
The refurbished cartridge was transported back to site in Egypt and fitted by our team to the pump casing. Despite not being stored properly on site, both cartridges were checked by our team and found to be in good order. They were fitted to the pump barrel and put into operation. The project was concluded within the 22-week allowed time. Pinnacle Re-Tec provided client with an improved, faster, and cheaper pump repair compared to the OEM, whilst still offering OEM equivalent guarantees.
