Case Study Centrifugal Compressor

OEM & Designation
Piller TSC Blowers
A-164

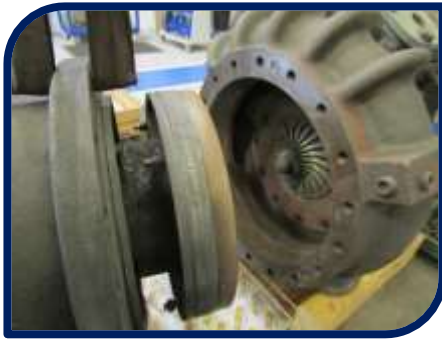
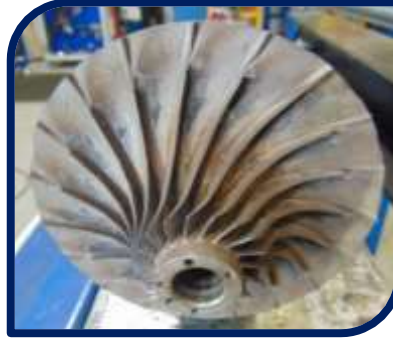
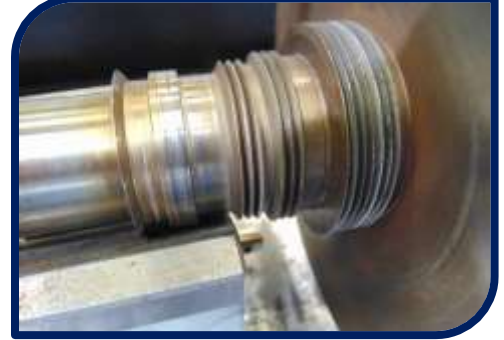
Centrifugal Compressor declared BER due to damage to shaft and impeller plus corrosion damage to compressor housing and shroud.

Pinnacle Re-Tec reverse engineered and manufactured in-house the required replacement Impeller, Inlet Shroud, Casing and shaft, utilising the latest CNC Technology. New impeller and shroud were machined in-house from solid material on one of our latest 5 axis CNC machines.

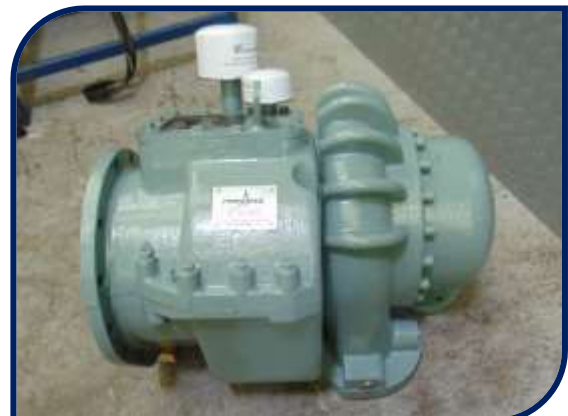
Pinnacle Re-Tec were able to provide the customer with a repair option for returning this AA Compressor back to service, when the OEM had deemed compressor as BER. The oil & gas client was able to return unit to service in reduced lead time and at significantly less cost than buying new replacement compressor.
