Breathing New Life into Old Equipment, with Innovative Solutions!

Case Study Vertical, Diffuser Bowl, ESP (VSO)

Sea Water Lift Pump
Sea Water

Weir
SBWM 660 – 1 stage,
U26 Motor

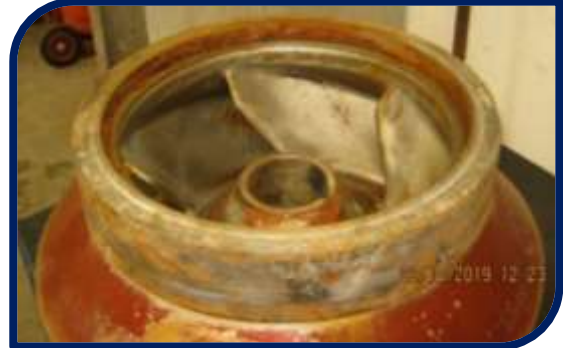
Electro Submersible pump was received seized due to significant galling damage caused by both rotating and stationary wear rings being manufactured from Zeron 100, which have a high tendency to gall against each other. The U26 Motor also required overhaul.
