Case Study Vertical, Diffuser Bowl, Lineshaft (VS1)

Duty & Fluid
Sea Water Lift Pump
Sea Water

OEM & Designation
Hayward Tyler
16HXB – 4 Stage

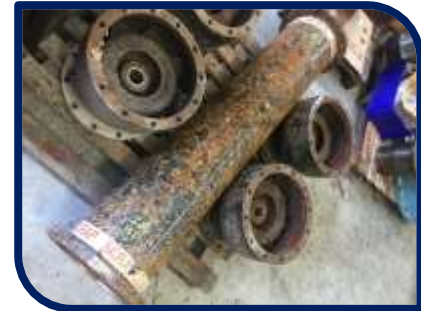
Historically pump materials used are reflective of the age of the platform and subsequently suffer badly from corrosion and failure. Typical issues can be galvanic reaction, spigot damage and pipe failure.

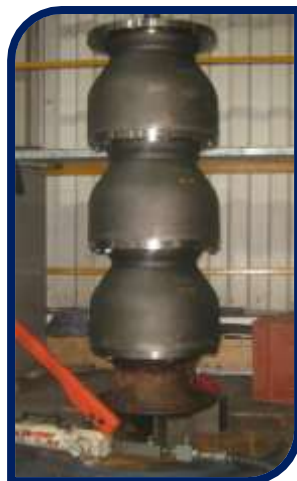
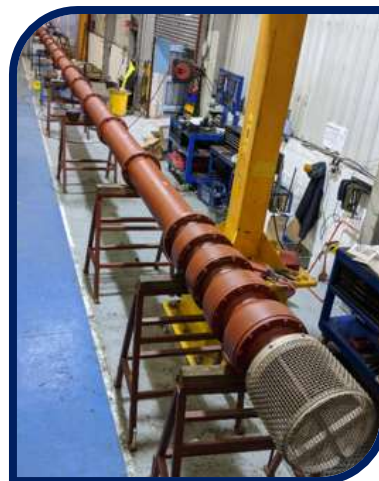
Pinnacle Re-Tec provided the client with a one-stop-shop, cost effective pump repair and delivered on time in 14 weeks.

Pinnacle Re-Tec were able to offer a cost-effective repair solution, by reverse engineering and manufacturing in-house all required spare parts. Out of tolerance column spigot locations were machined in-house and repair rings fitted and pinned, then finish machined to required size. Bearing bushes can be replaced in variety materials – Flourosint, Peek or Cutless rubber.
