Case Study Multi-Stage Split Cartridge, Barrel (BB5)

Clyde Union
6x8x13 DB36 – 10 stg
Boiler Feed Pump

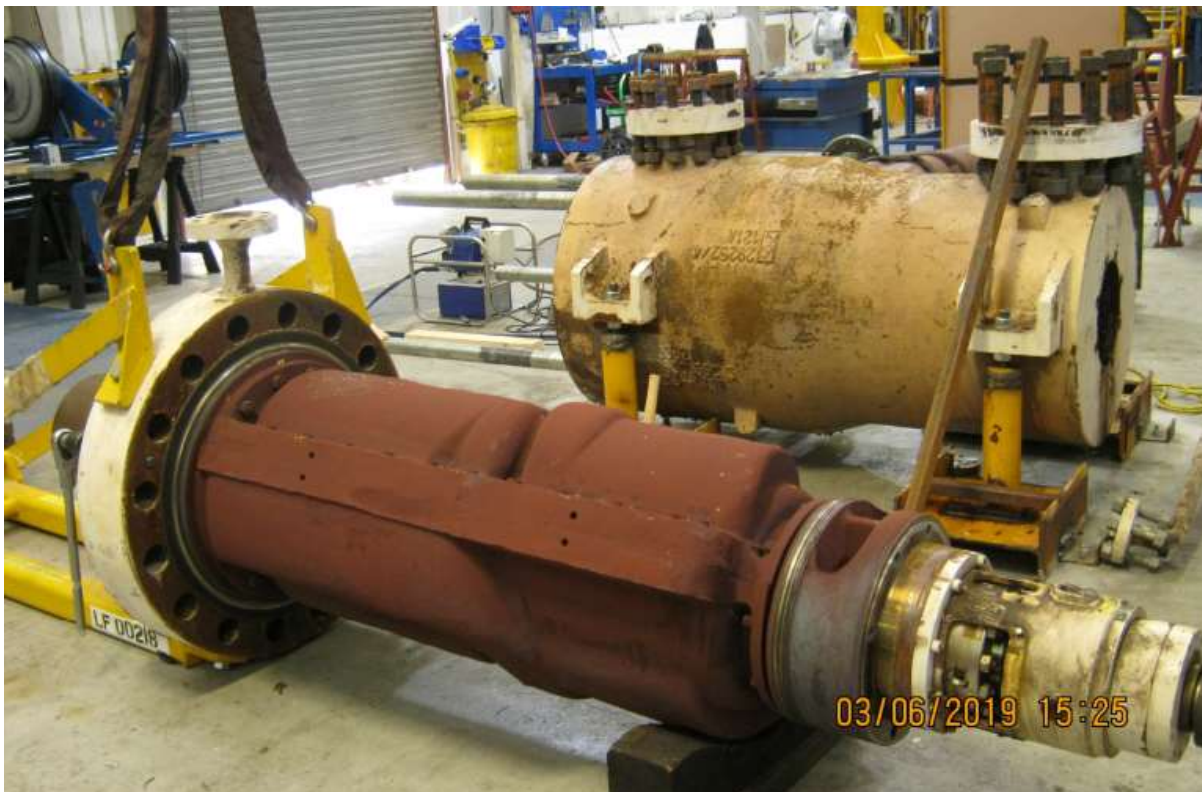
Rotating element being stripped down, prior to manufacture of new wear rotating parts.

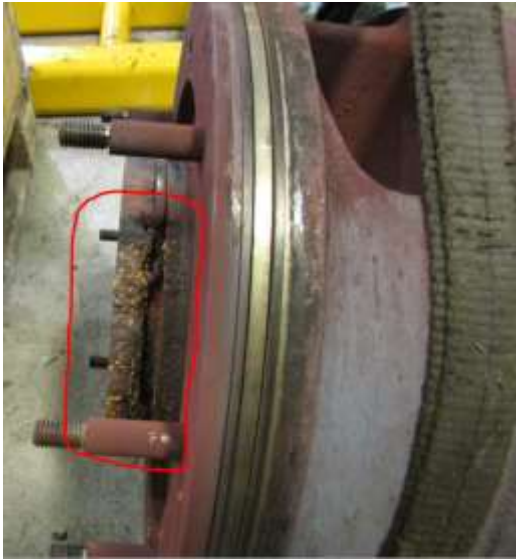
Pinnacle Re-Tec reverse engineered and manufactured the required spare parts in-house. The suction piece was damaged on locating diameter to cartridge, this was weld repaired by 3rd party with full weld procedures in place, then machined to finish size in-house at Pinnacle Re-Tec. Picture to right, is repaired suction piece fitted to cartridge during rebuild.

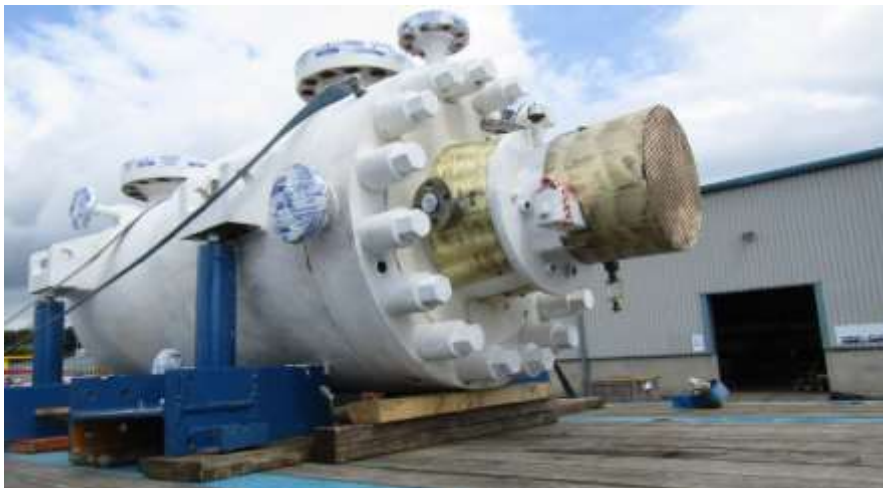
The refurbished cartridge was fitted to the pump barrel and pressure tested prior to being delivered back to client at UK Refinery, within the 16-week lead time for changeout. We have overhauled several of these units in the past 2 years for this client. Pinnacle Re-Tec provided client with an improved, faster, and cheaper pump repair compared to the OEM, whilst still offering OEM equivalent guarantees.
