Breathing New Life into Old Equipment, with Innovative Solutions!

Case Study Multi-Stage Split Cartridge, Barrel (BB5)

Duty & Fluid	OEM & Designation	Materials
Boiler Feed Pump. Water	Siemens Delaval 7 stage Type 5BB81510	Carbon Steel Hydraulic components, Stainless Steel shaft.

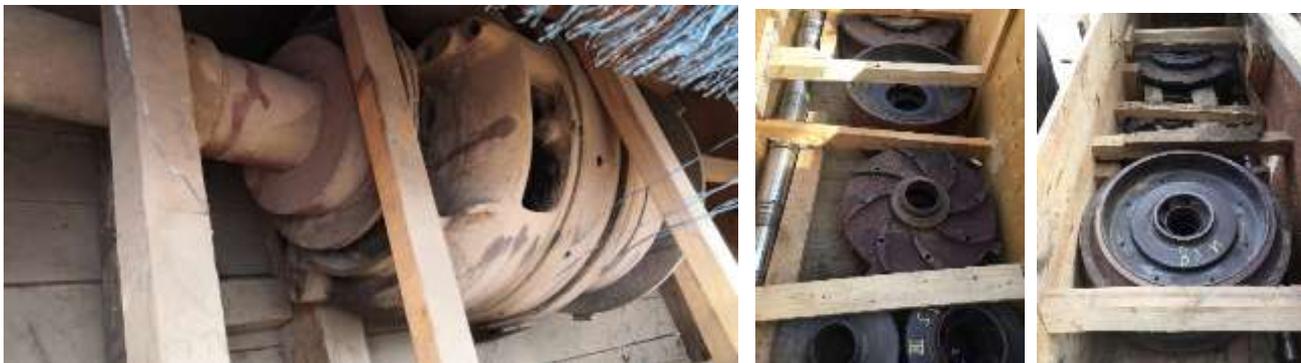
Presentation of cartridges and parts on site.

We have been overhauling these units for the customer for over 15 years and are usually required to come to site and select suitable old parts to build 2 or 3 new cartridges. The rotating parts are usually beyond repair, but the casing parts are serviceable. The customer requires complete reverse engineered rotor and refurbishment of the cartridge, ready for service in 24 weeks.

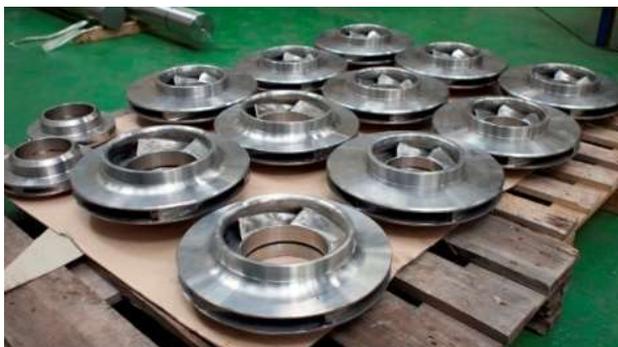
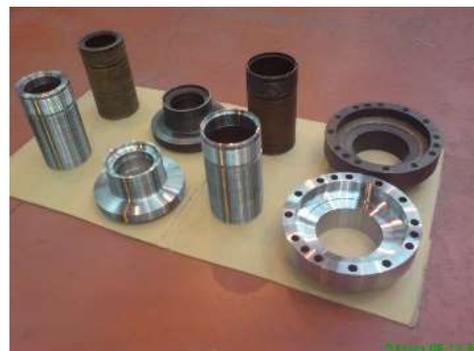
New impellers, old and new balance drum and sleeves and final skimming of rotor post assembly for balancing

Pinnacle Re-Tec select suitable parts and transport them back to the UK for refurbishment. All parts have been reverse engineered so that we can start production of all new parts as soon as we have a PO and don't need to wait for sample parts. The casing parts are refurbished and assembled together with the rotor to form a complete ready to install cartridge. The shipment usually also includes parts that are added during the assembly on site such as balance drum and sleeves.

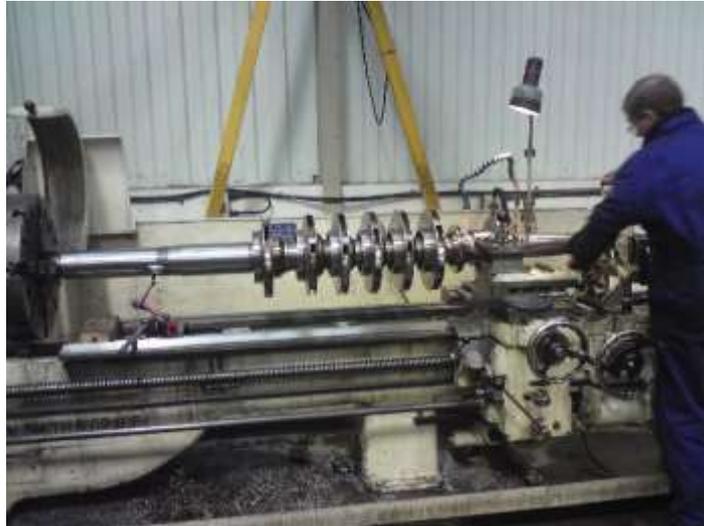
Duty & Fluid	OEM & Designation	Materials
Boiler Feed Pump. Water	Siemens Delaval 7 stage Type 5BB81510	Carbon Steel Hydraulic components, Stainless Steel shaft.

Reverse engineering and manufacturing inhouse ensured that not only did our client benefit from a cost effective pump repair solution. The added benefit is our capability to repair damaged parts and re-use all serviceable parts to minimise the cost. In this case, our approach has resulted in repeat orders every other year from a very satisfied customer.

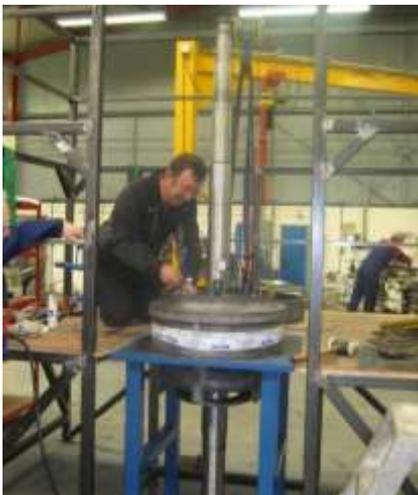
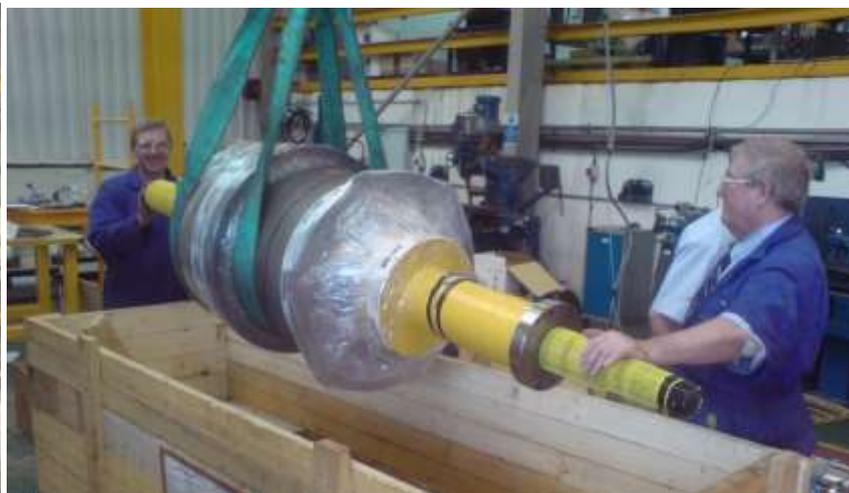
Customer received a complete refurbished cartridge assembly, fitted in the new rotor within the 24 week deadline. Pinnacle RE-Tec provided client with an improved, faster and cheaper pump repair compared to the OEM. The customer has repeated the same order every 2 years, all 12 pumps in the power-station are now from Pinnacle RE-Tec.
